STRUCTURAL CONDITION SURVEY OF EXISTING MIDDLETOWN MUNICIPAL PARKING GARAGE

MIDDLETOWN COURTHOUSE PROJECT
MIDDLETOWN, CONNECTICUT

APRIL 1992

PURCELL
ASSOCIATES

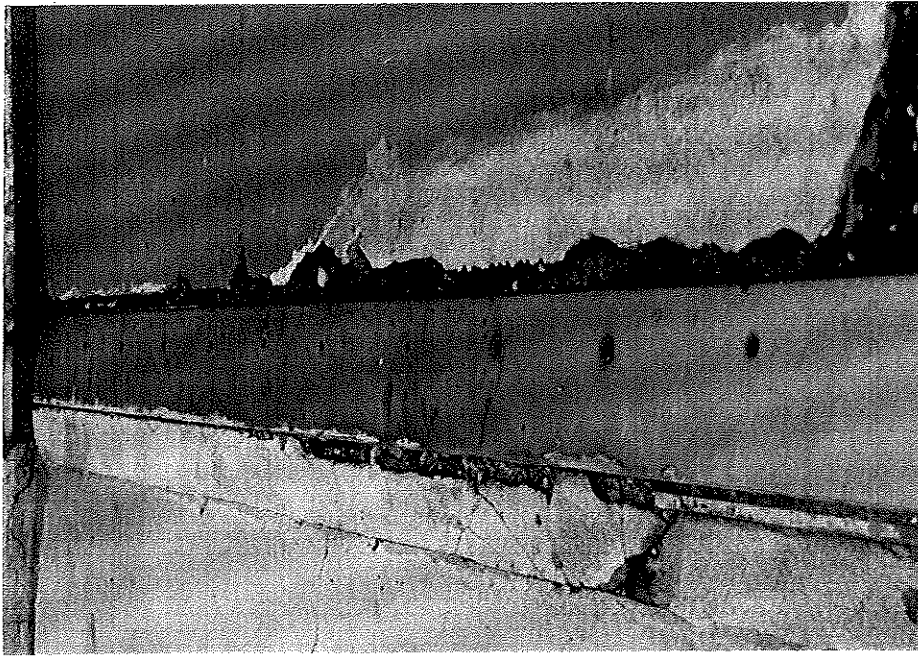
55

55. Deteriorated concrete immediately adjacent to the expansion joint that separates the pedestrian bridge and Stair No. 2.
56. Cracked masonry in fill underneath the W27 girders at Stair No. 2.

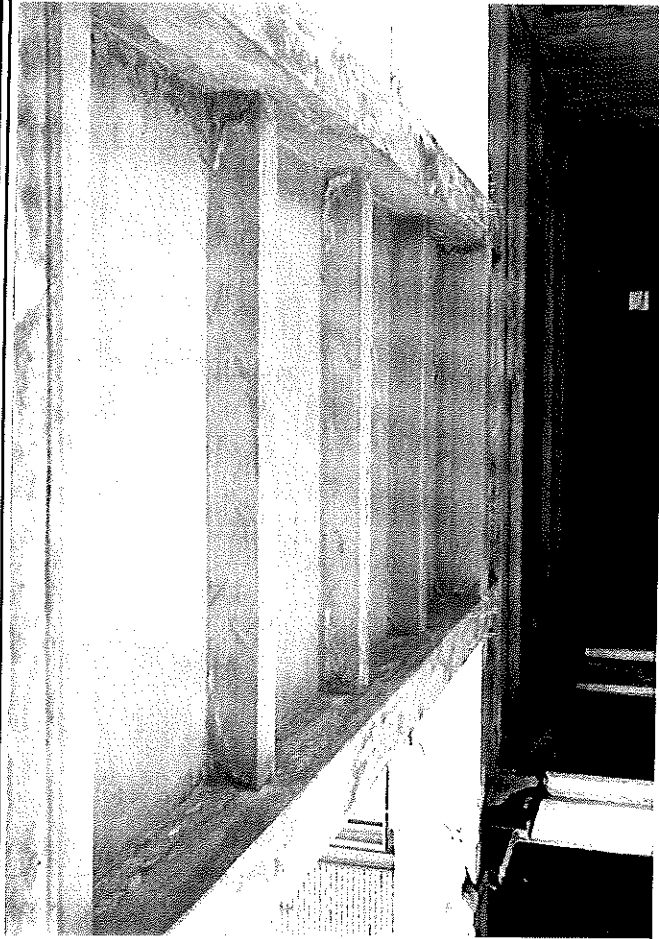
57

57. Underside of pedestrian bridge looking west. Stalactites and efflorescence can be seen in concrete encasements around W27 girders.
58. Underside of pedestrian bridge looking east and west elevation of Stair No. 2. Severely deteriorated masonry infill underneath pedestrian bridge can be seen.
59. Steel pipe column heavily rusted near top and severely deteriorated masonry infill.
60. Cracked masonry infill and steel column that is heavily rusted near top.
61. Heavily rusted and delaminated steel beam at the northeast corner of Sears Building.
62. Heavily rusted and delaminated south end of transverse girder that supports the W27 girders and pedestrian bridge.
63. Random cracks in concrete topping over pedestrian bridge deck slab.
